**DEPARTMENT OF TRANSPORTATION**

Contract #: 04-0120F4Cty: SF/ALA Rte: 80 PM: 13.2/13.9File #: 69.28**WELDING INSPECTION REPORT****Resident Engineer:**Siegenthaler, Peter**Address:** 333 Burma Road**City:** Oakland, CA 94607**Report No:** WIR-024722**Date Inspected:** 25-Jun-2011**Project Name:** SAS Superstructure**OSM Arrival Time:** 700**Prime Contractor:** American Bridge/Fluor Enterprises, a JV**OSM Departure Time:** 1900**Contractor:** Zhenhua Port Machinery Company, Ltd (ZPMC), Changxing Island **Location:** Shanghai, China

## WELDING INSPECTION REPORT

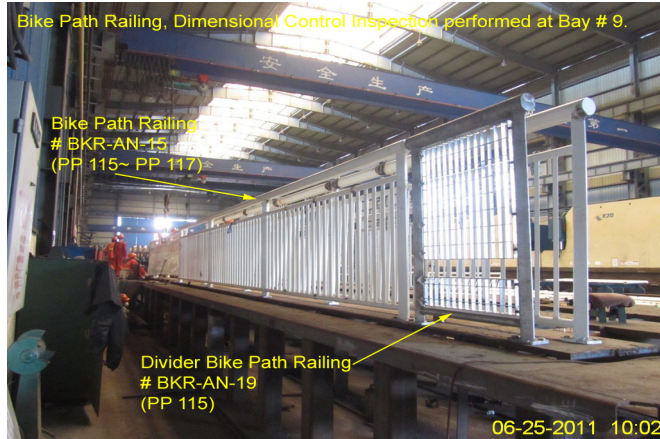
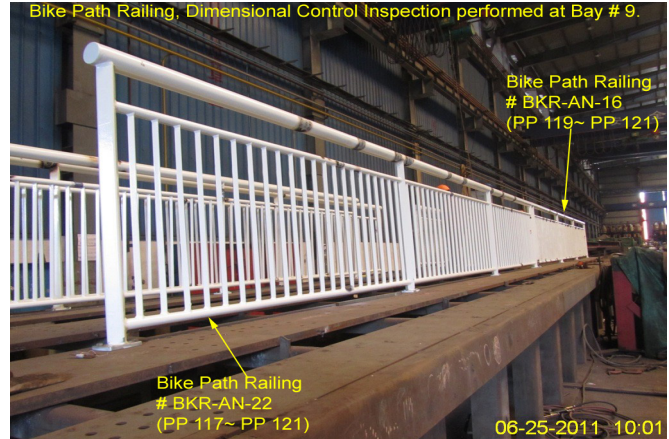
Performed the Dimensional Inspection and observed results are in general compliance with the tolerances, during the course of inspection ZPMC Mr. Chen Shi Gang and ABF Mr. Liu Cheng were present. Informed the results of Inspection to Caltrans Lead Inspector for further disposition.
